CALSPAN ON-SITE AIR BAG DEPLOYMENT INVESTIGATION

CALSPAN CASE NO. 91-3

**VEHICLE - 1990 GEO STORM GSi
LOCATION [REDACTED], LOUISIANA
ACCIDENT DATE - [REDACTED] 1990**

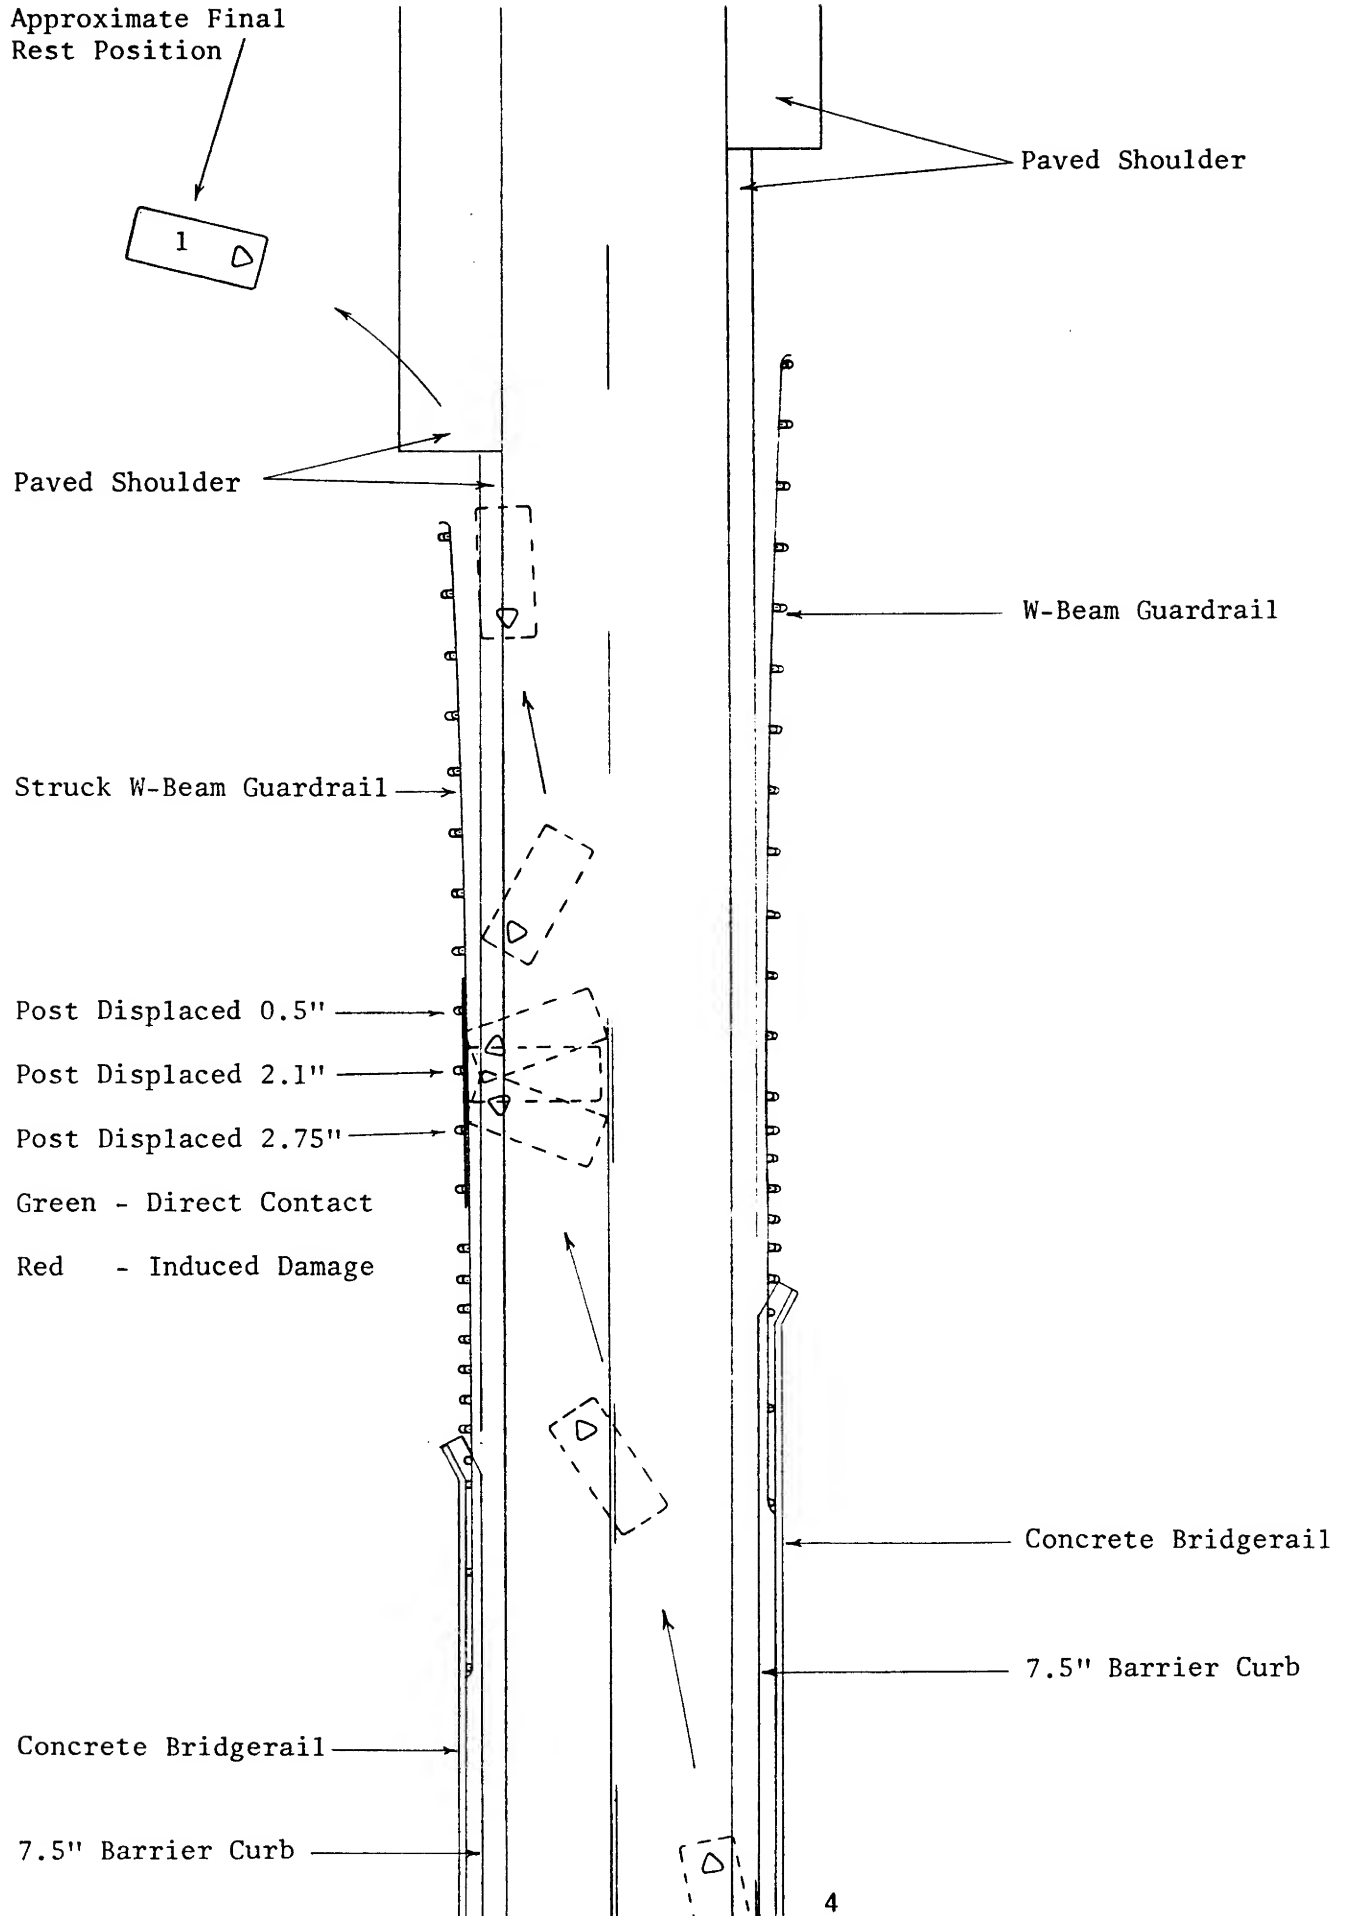
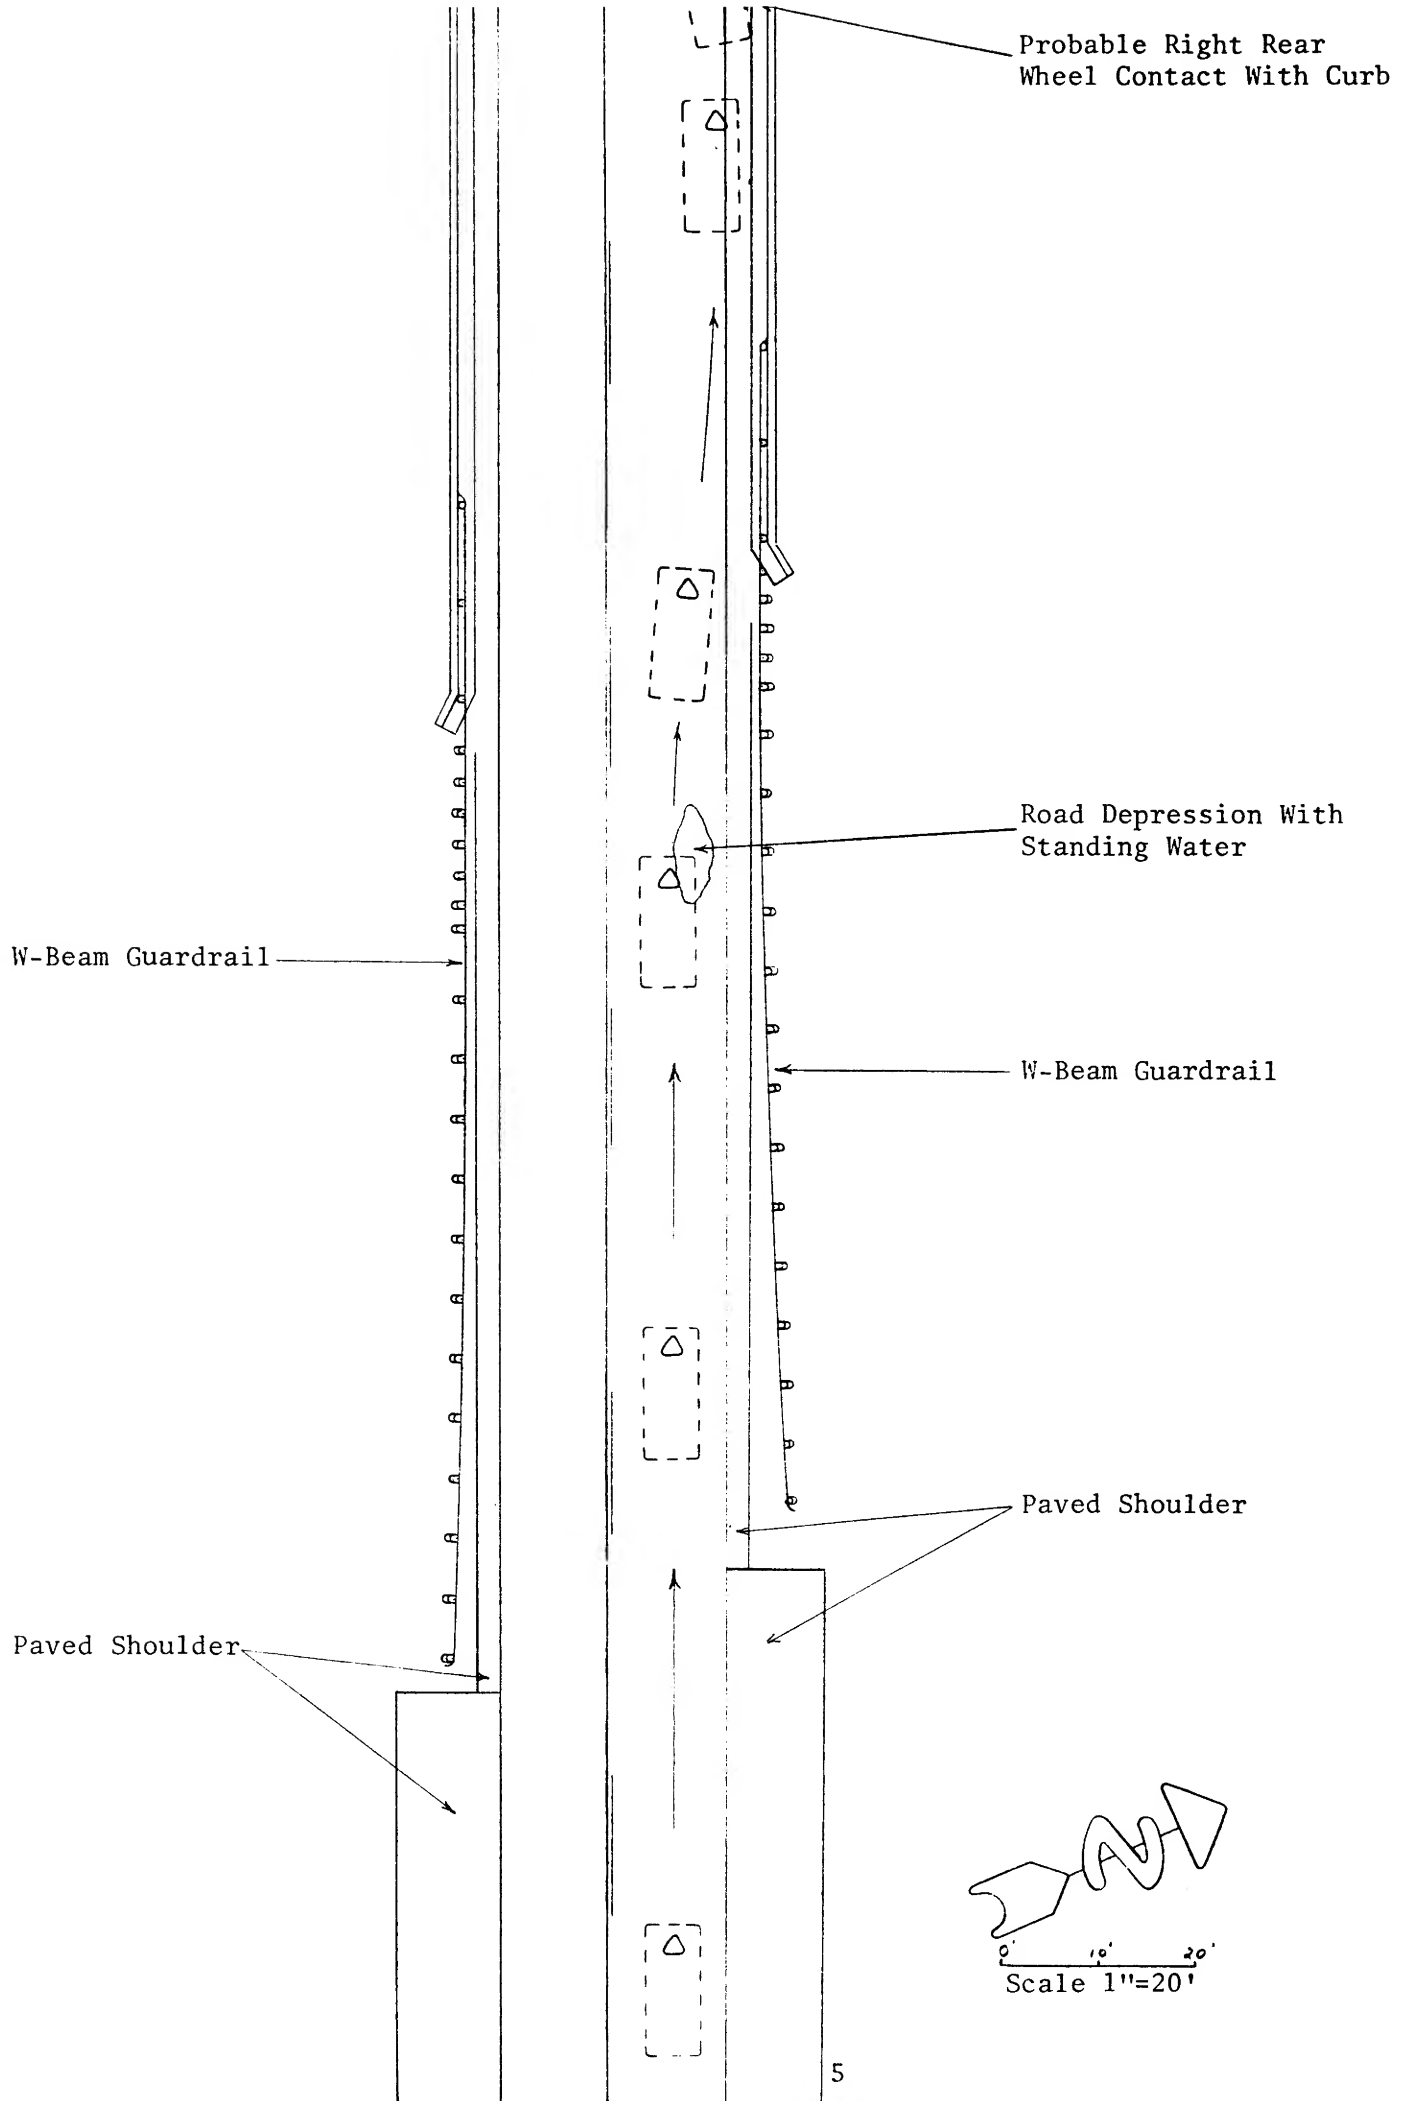
ACCIDENT SCHEMATIC
CALSPAN CASE NO. 91-03

The Geo Storm broke traction on the wet road surface and initiated a CCW yaw. The right rear tire and wheel impacted the right (north) curb as the tire was rotating, resulting in abrasions to nearly the entire circumference of the aluminum wheel. The wheel also impacted the curb with sufficient force to bend the rear toe adjustment arm that was located rearward of the axle center. The arm deformation resulted in a steer angle of +10° (leading edge of wheel assembly was toed outward) to the right rear wheel. Two possible areas of contact with the curb were noted (polishing and gouging of the curb face); however, due to the two month time interval between the date of the crash and scene inspection, it was impossible to determine the exact contact area.

Direct contact damage (i.e., paint transfers, scratching) on the W-beam guardrail was 2.9 m (9'5") in length. The overall deformed length of guardrail spanned 7.3 m (23'11") with a maximum crush value of 15.2 cm (6"). The impact also displaced three of the 20 x 20 cm (8" x 8") wood guardrail posts to a maximum displacement of 7.0 cm (2.75").

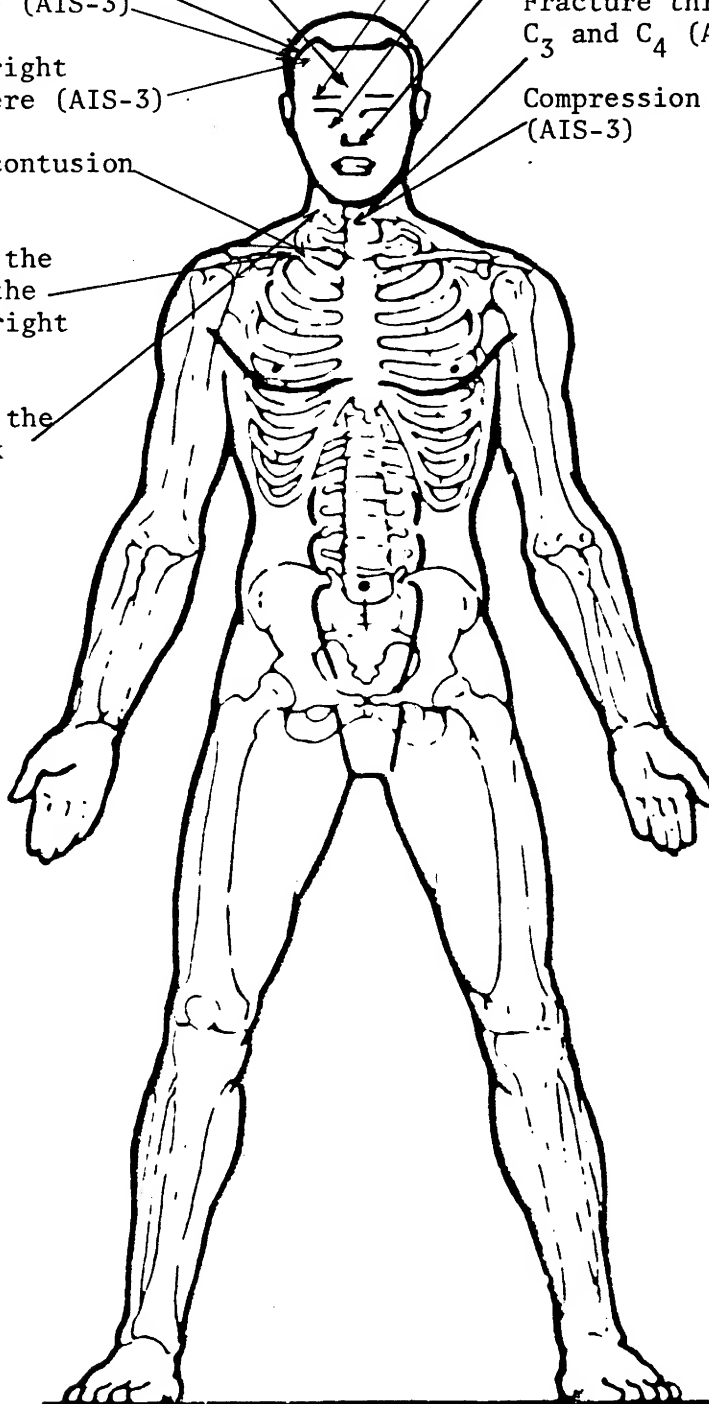
- Fracture of the right orbit (AIS-2)
- Large hinge fracture through the base of the skull (AIS-4)
- Cerebral edema (AIS-4)
- Subdural hemorrhage (AIS-3)
- Contusions of the right cerebellar hemisphere (AIS-3)
- Upper right chest contusion (AIS-1)
- Large contusion of the lateral aspect of the upper lobe of the right lung (AIS-3)
- Large contusion of the right anterior neck (AIS-1)
- Fracture of the right maxillary sinus (AIS-2)
- Fractured nasal bones (AIS-1)
- Fracture through the disc at C₃ and C₄ (AIS-2)
- Compression of the spinal cord (AIS-3)
